DPA 4 – Rocky Beach Front/Escarpment, Rockfall and Upland Slope Hazards

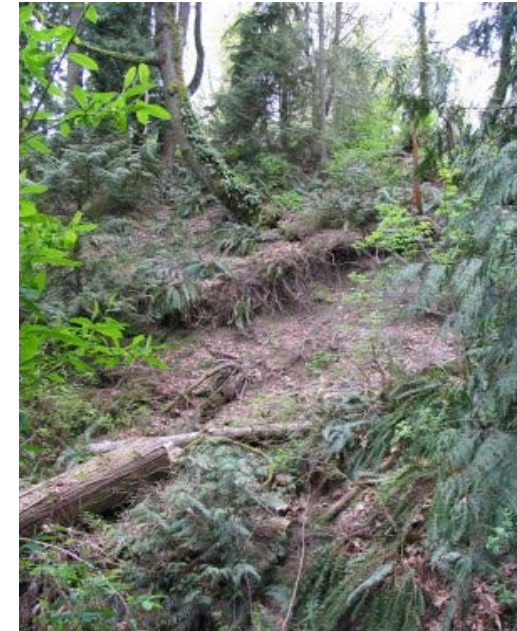
* *Unstable soils on upland slope.*

The soils are subject to potential shallow instability, small debris landslides and to minor storm wave erosion where they are exposed along the beachfront. Creep and shallow instability in the surficial soils have been observed.

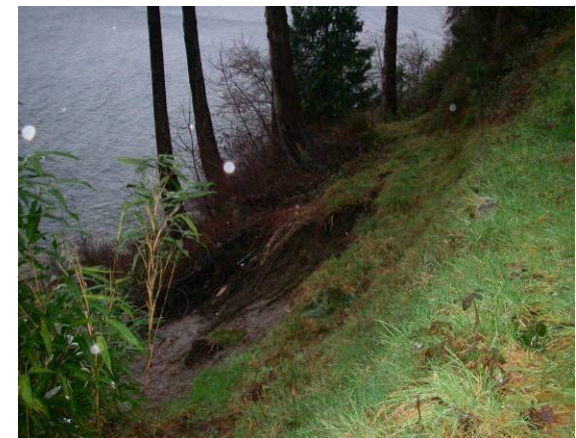
* *Recent slope failure in Davis Bay/Selma Park after heavy rains.*
